### 5TH FLOOR BOILER HOUSE SECTION VII ROOMS 7.06H

**Non-TCRA Building Assessment  
Avtex Fibers Superfund Site**

## POLYMER PLANT 5TH FLOOR SECTION I

ROOM 1.05 F

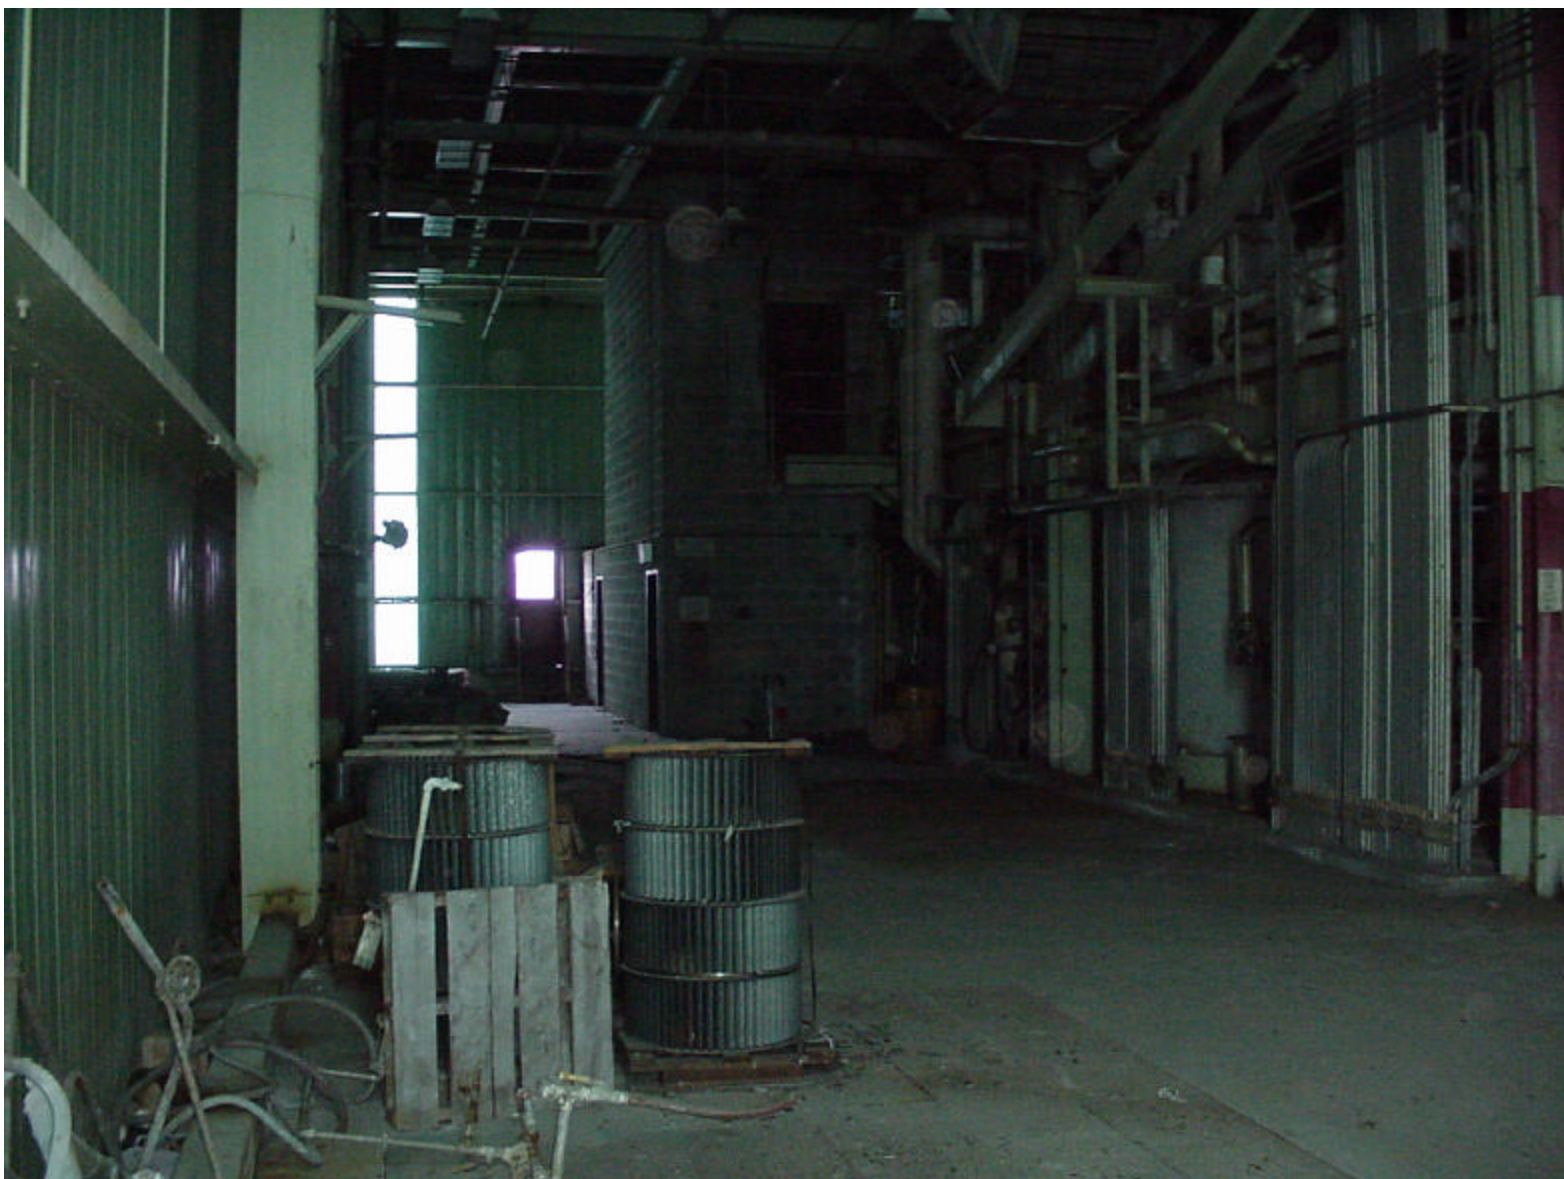
Photograph ID	Date Taken	Section #	Room #	Room Description	Description
MVC-1103	1/19/00	I	1.05F	Polymer Plant	General view of room looking west from the southeast

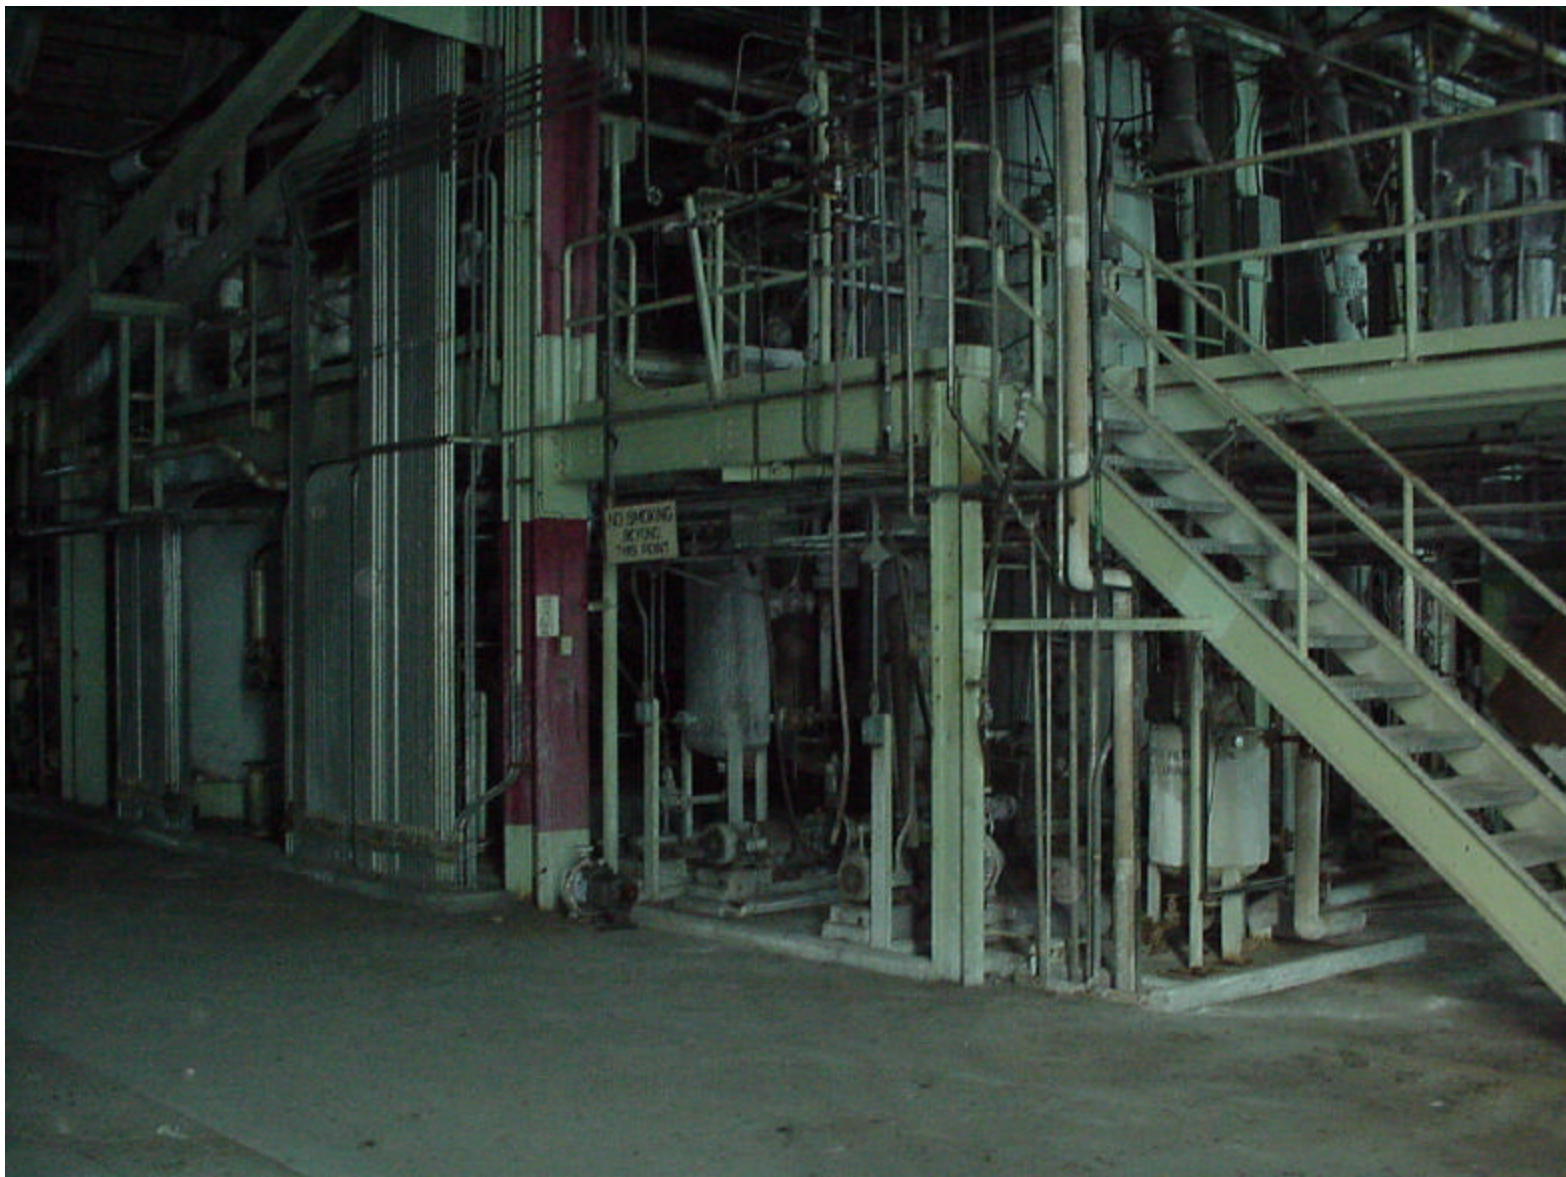
Photograph ID	Date Taken	Section #	Room #	Room Description	Description
MVC-1104	1/19/00	I	1.05F	Polymer Plant	General view of room looking northwest from the southeast

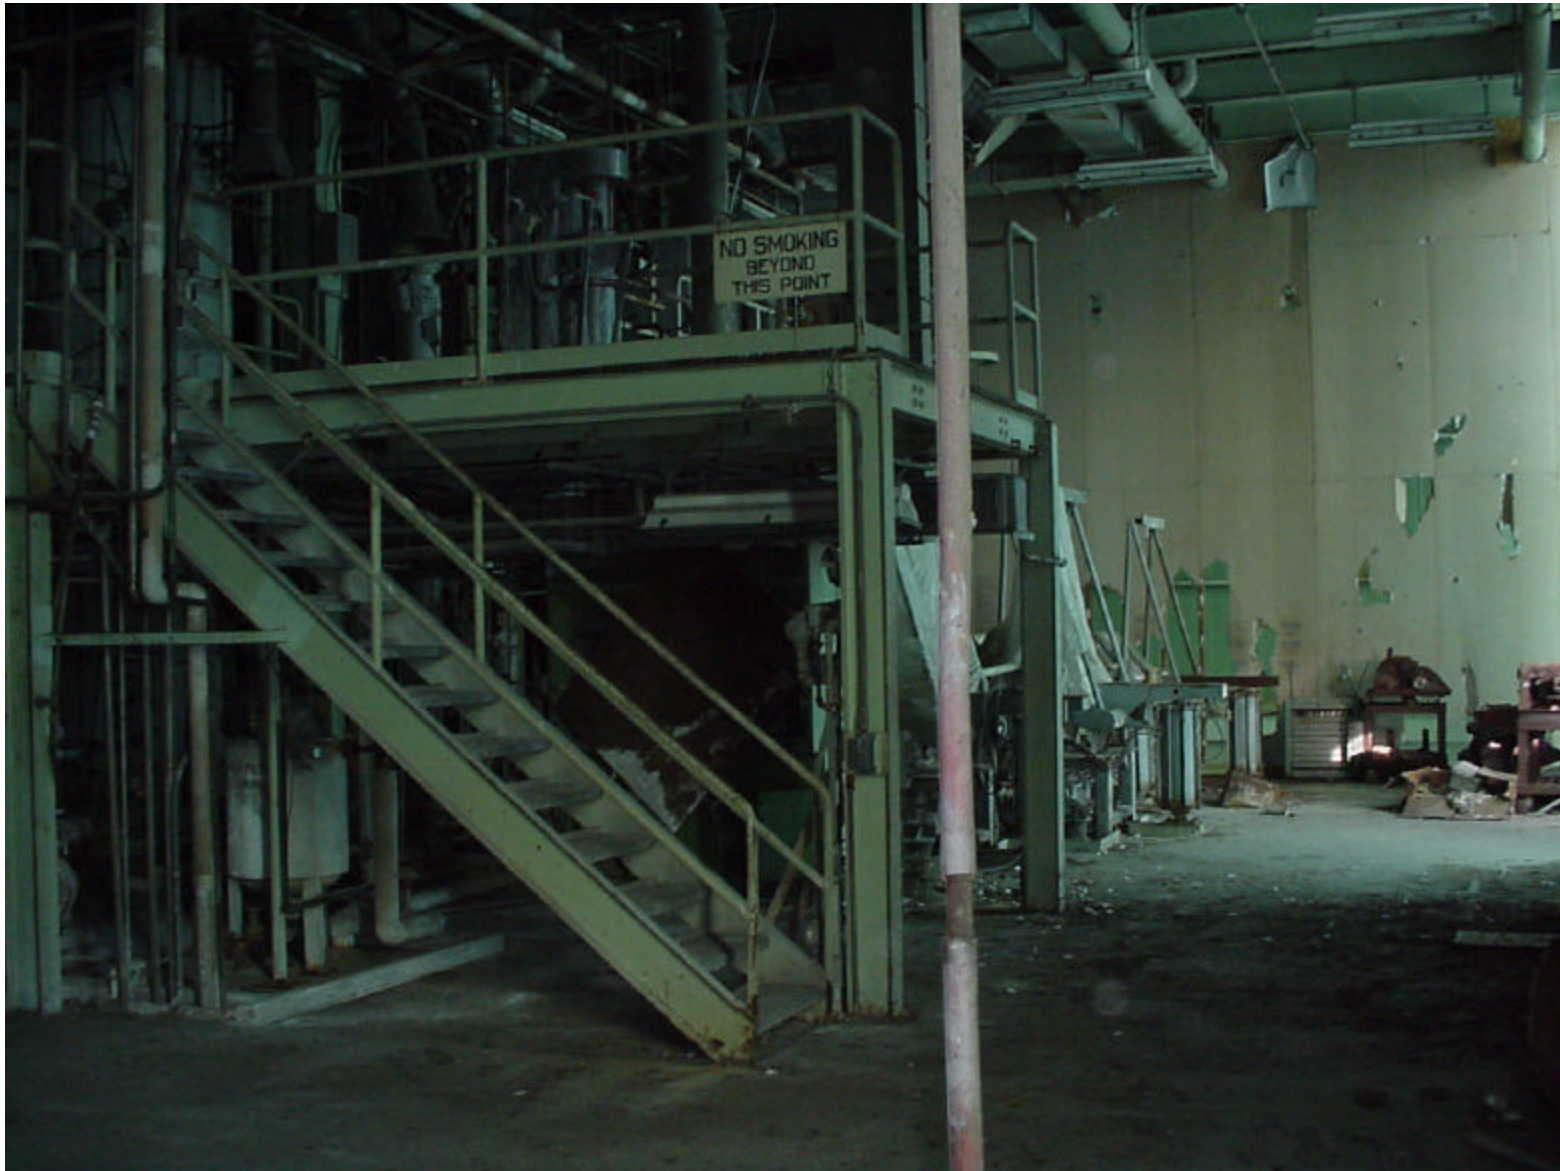
Photograph ID	Date Taken	Section #	Room #	Room Description	Description
MVC-1105	1/19/00	I	1.05F	Polymer Plant	General view of room looking north from the southeast

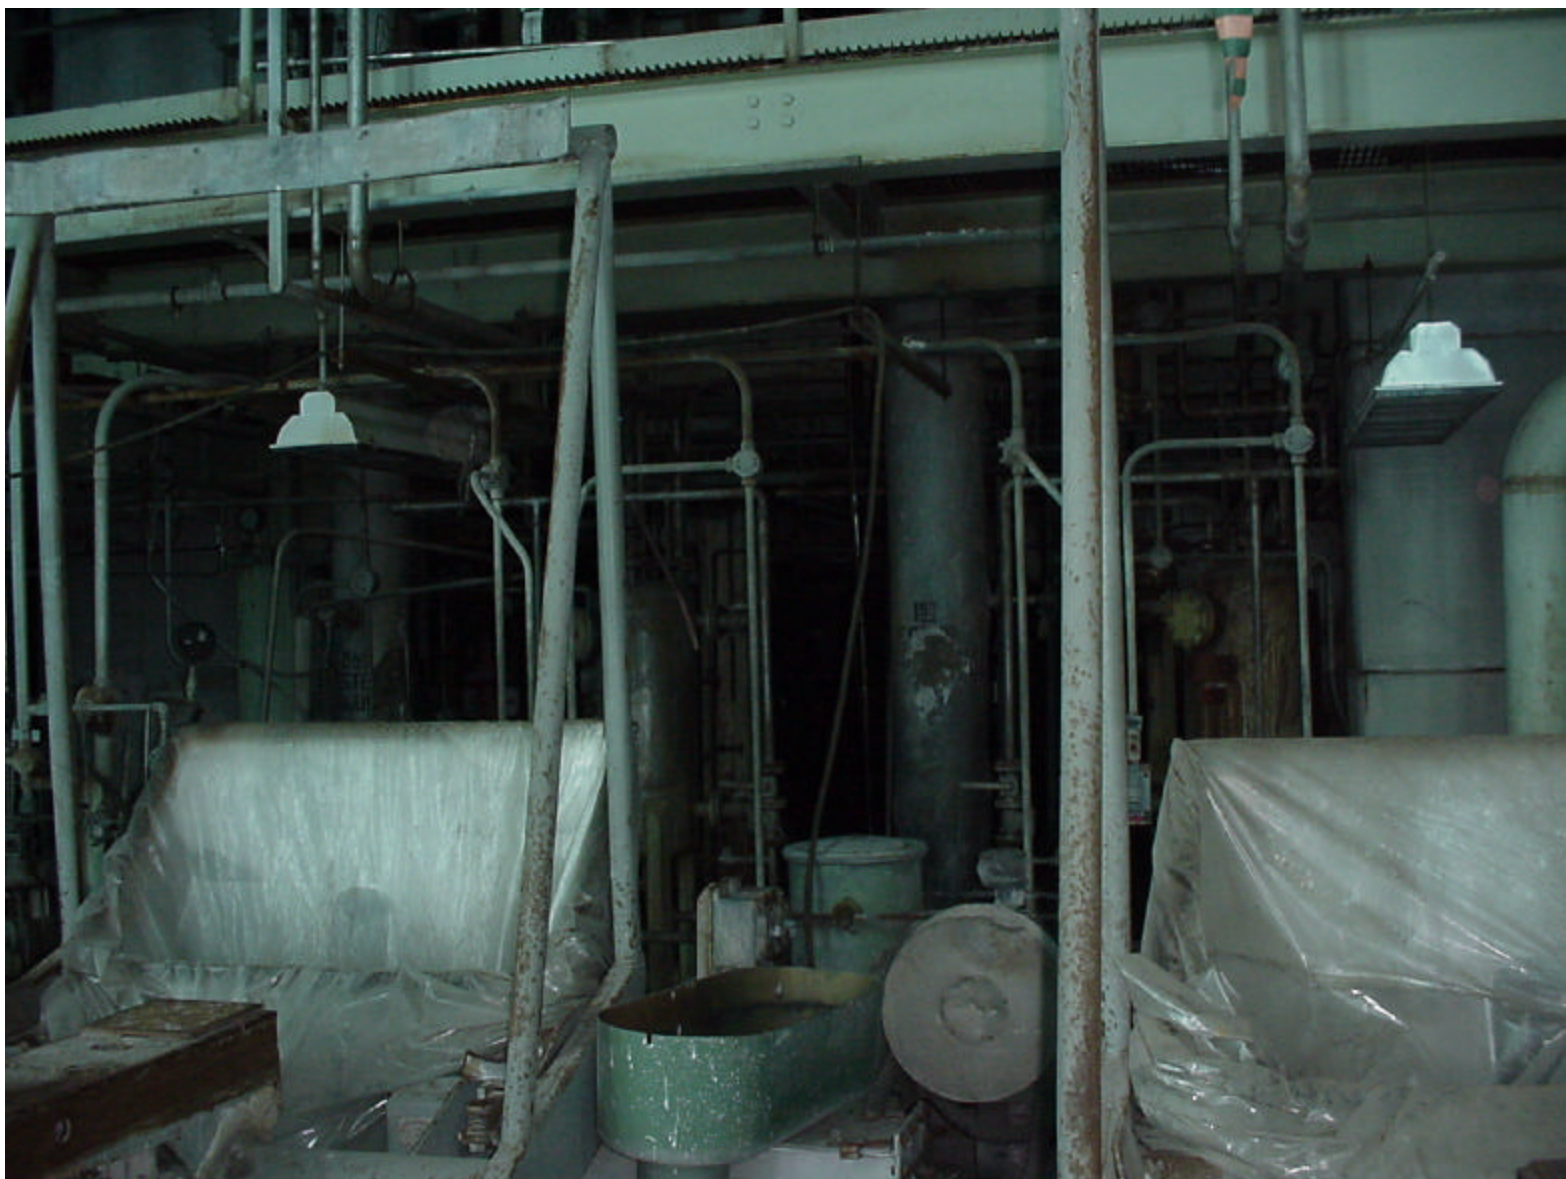
Photograph ID	Date Taken	Section #	Room #	Room Description	Description
MVC-1106	1/19/00	I	1.05F	Polymer Plant	General view of room looking west from the northeast

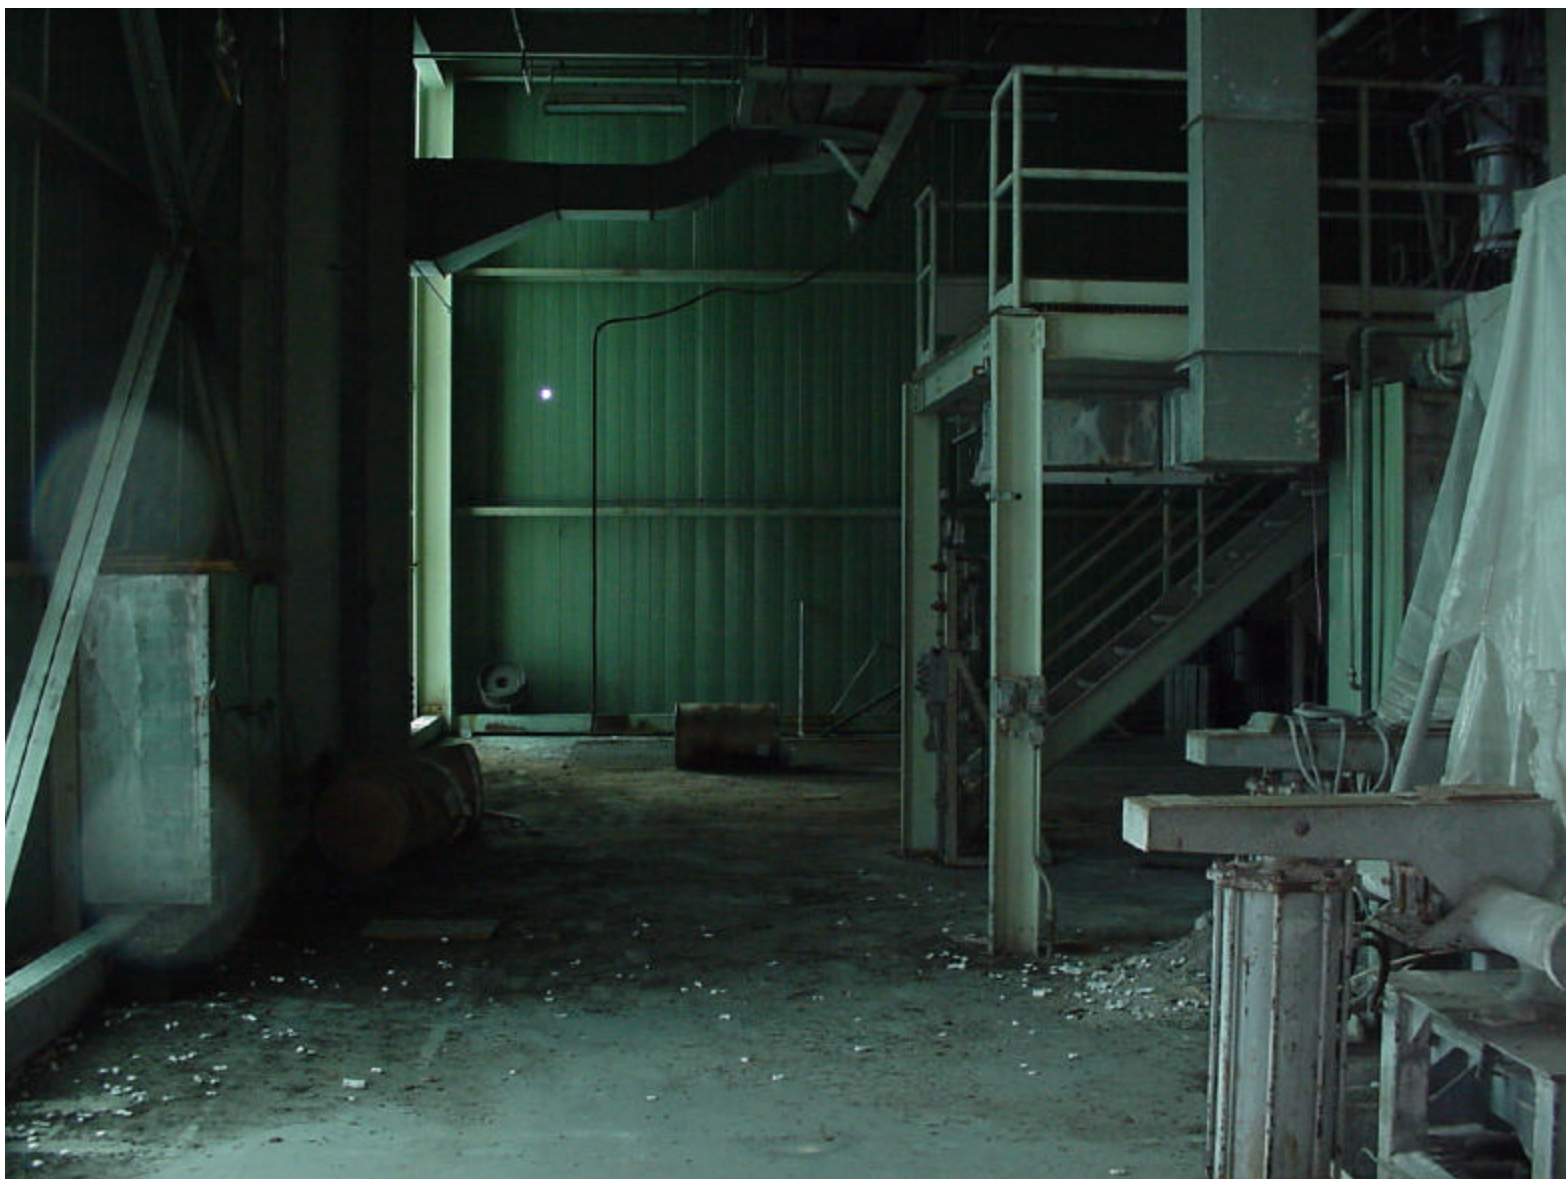
Photograph ID	Date Taken	Section #	Room #	Room Description	Description
MVC-1107	1/19/00	I	1.05F	Polymer Plant	General view of room looking south from the northeast

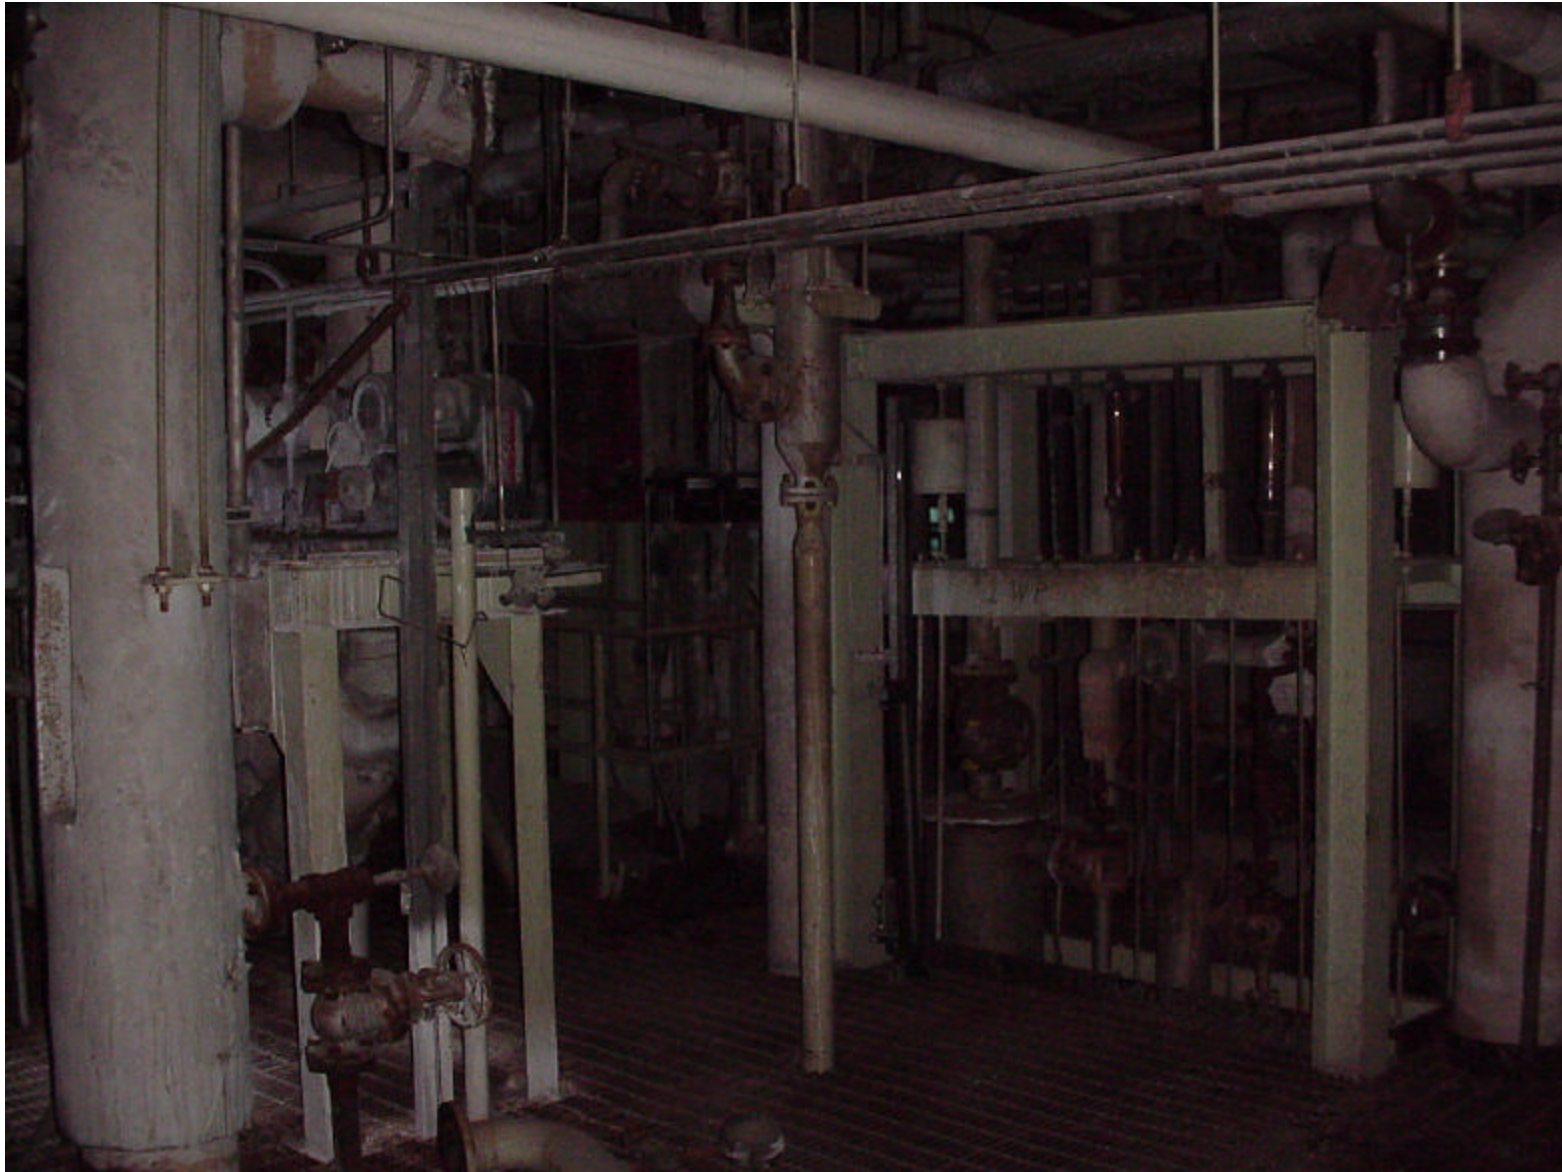
Photograph ID	Date Taken	Section #	Room #	Room Description	Description
MVC-1108	1/19/00	I	1.05F	Polymer Plant	General view of room looking northwest from the 5th floor mezzanine

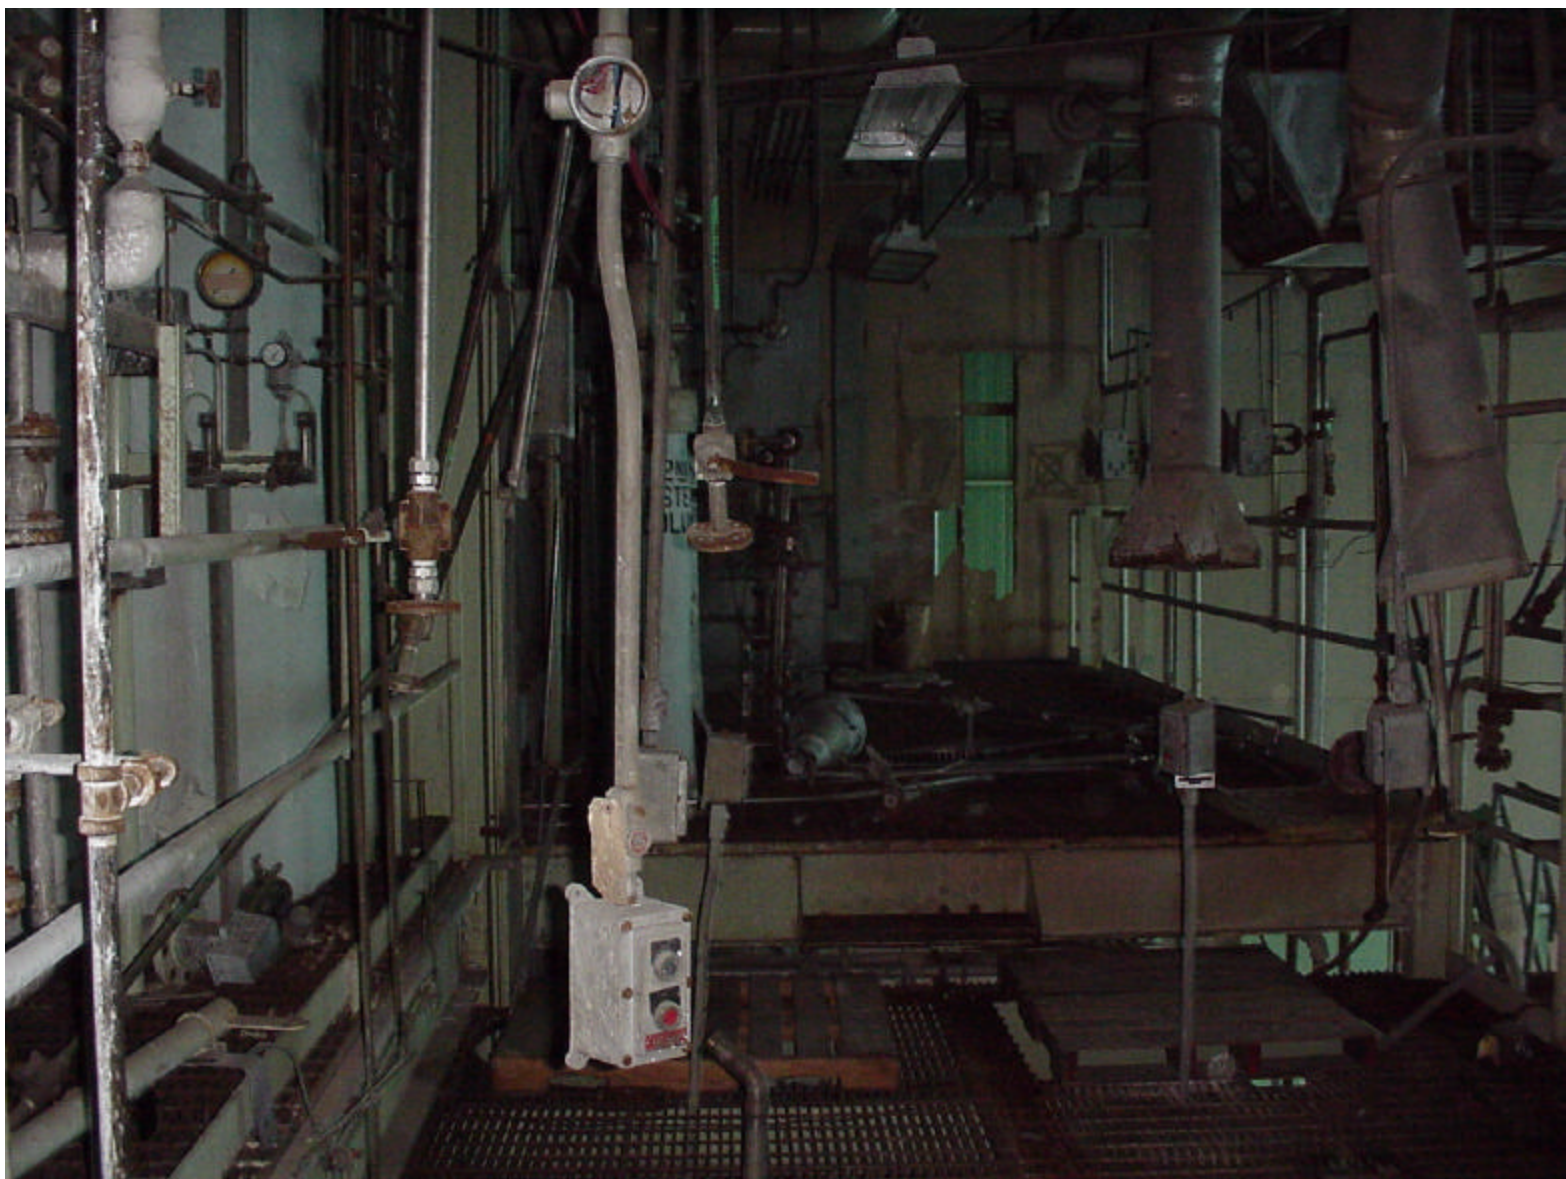
Photograph ID	Date Taken	Section #	Room #	Room Description	Description
MVC-1109	1/19/00	I	1.05F	Polymer Plant	General view of room looking north from the 5th floor mezzanine
